БЕТОН КАК ОДИН ИЗ ФАКТОРОВ ОБРУШЕНИЯ ЖЕЛЕЗОБЕТОННЫХ ЗДАНИЙ В БУРУНДИ

CONCRETE AS A FACTOR IN REINFORCED CONCRETE BUILDINGS COLLAPSE IN BURUNDI

Introduction. This paper presents the results of the assessment in-situ of the involvement of the concrete in the collapse of reinforced concrete buildings in Burundi.

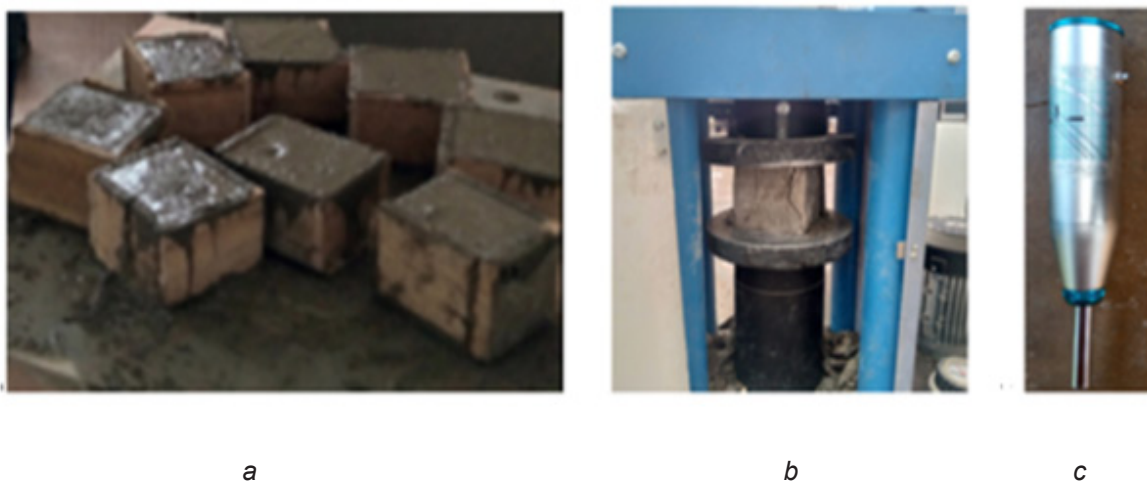
Figure 1 – Experimental samples preparation (a) and compression testing under hydraulic press (b) and sclerometer (c) used in the laboratory and in-situ study
Source: compiled by the authors.

The main instrument that was planned to be used in the investigation of the studied structures was the sclerometer «SCHMIDT 2000». Thus, the first step of the research was to identify the correlation between the results obtained from the compression test under the hydraulic press and the results given by the sclerometer on the same experimental samples of the ordinary concrete (Fig.1). Two cement grades were considered for the concrete: low-grade cement (32.5) and high-grade cement (42.5).

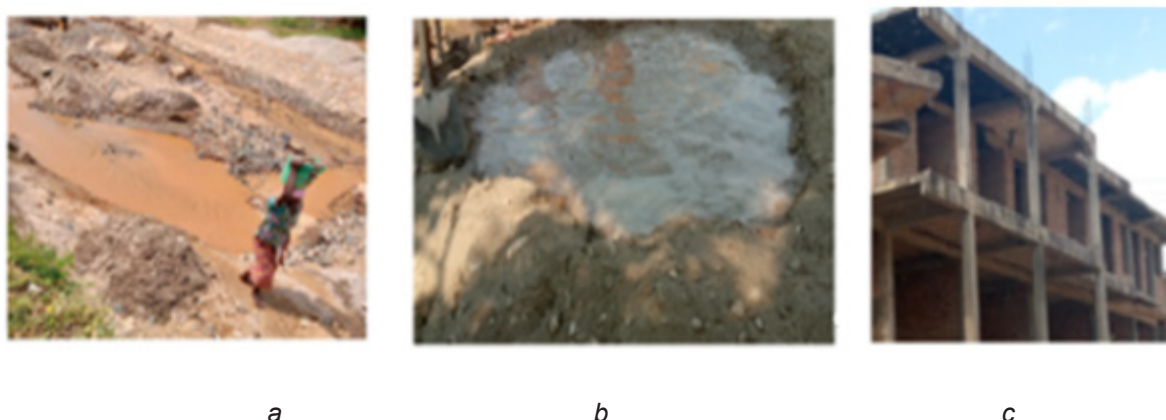
Figure 2 – Random example of source of construction materials (a) used in manufacturing concrete (b) used in individual reinforced concrete buildings (c) in Burundi
Source: compiled by the authors.

The next step was to visit the construction sites in progress in order to observe visually the quality of the construction materials, technology and workforce used in the execution of reinforced concrete constructions (Fig. 2).

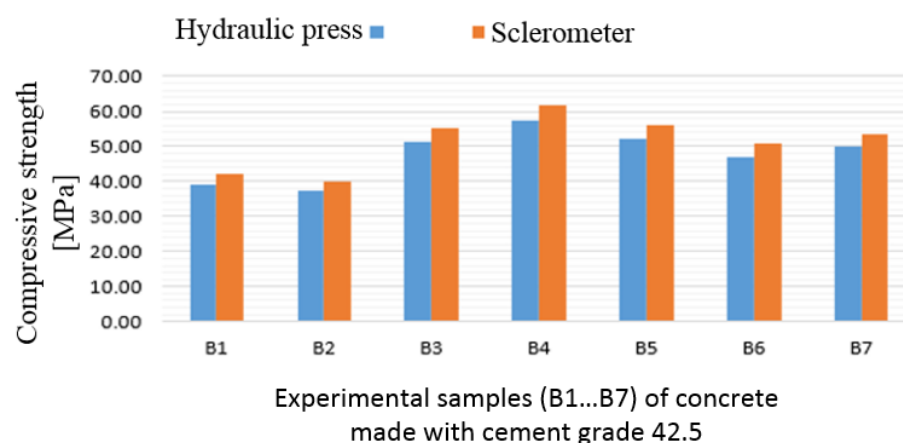
Figure 5 – Comparative results of compressive strengths obtained under the hydraulic press and the sclerometer on the same experimental concrete samples with cement grade (42.5)
Source: compiled by the authors.

To start with, the results obtained show a good correlation between the tests obtained under the hydraulic press and the sclerometer (Fig.4; Fig.5).

As the results show (Fig.4, Fig.5), for concretes aged 28 days, the compressive strengths obtained by crushing under the hydraulic press are lower than those determined by the sclerometer with a maximum difference of 7%.
